# BROKEN INSULATORS REPAIRED WITH BELZONA

Insulator Bushings.

Power plant , Egypt.

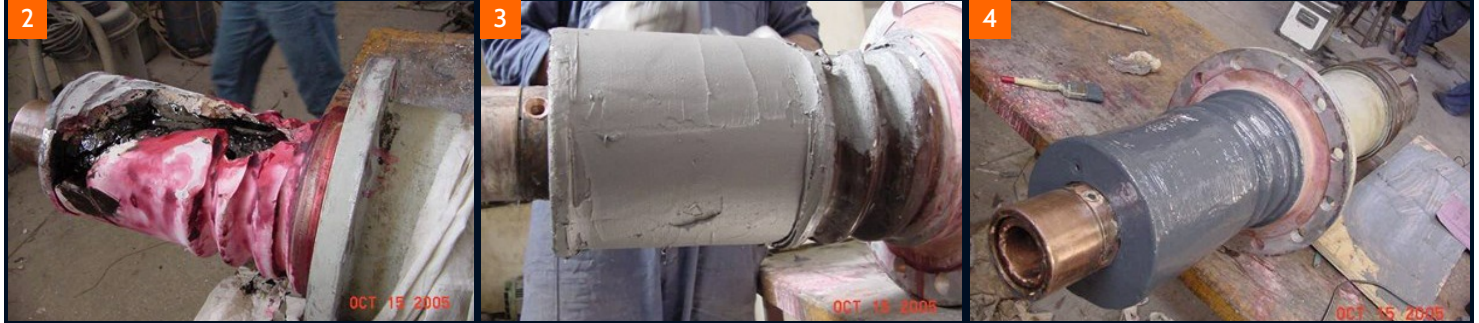
Two Insulators were cracked and broken. Also the copper pipe inside one of them was broken.

1. The broken Insulator.
2. The second Insulator.
3. Belzona 1111 was applied to fill the cracks and broken areas.
4. Repaired Insulator.

Application was carried out in accordance with modified Belzona Know-How system leaflets VPF-1 & VPF-2. Original profiles were restored with Belzona® 1111 and smooth top surface created using Belzona® 1391.

Belzona perfectly repaired the badly broken Insulators saving the costs of new units beside the long import time. After the repair the dry resistance of the insulators was measured and found to be about 5000 mega ohm which was much higher than the normal resistance of the old insulators.
