# BELZONA BALL MILL BEARING PLATE

ID: 65

Coal pulverizer-ball mill bearing plate

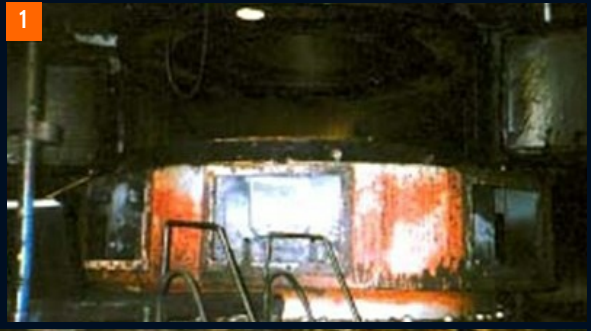
1. Outside view of the coal pulverizer.
2. Holes behind bearing plate of ball mill.
3. Holes sealed, Belzona 1811 in place.

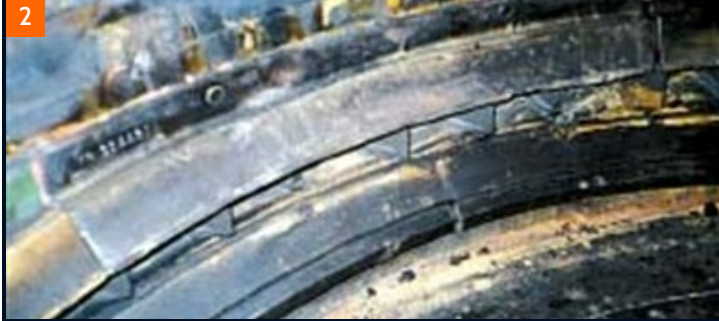
Coal fines cause wear behind the bearing plate resulting in holes and allowing coal to drop out of the pulverizer.
