# BELZONA PUMP RESTORATION

ID: 652

Water Plant, Egypt

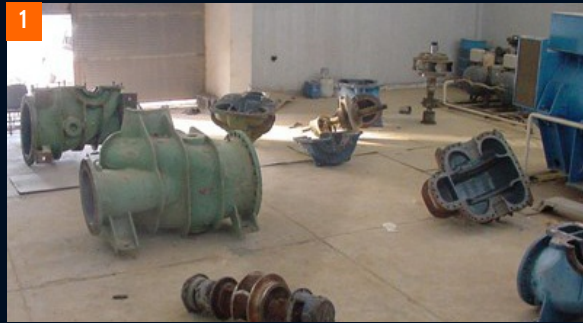
The four pumps were very badly eroded and corroded. As a result, the flow rate was much lower than the normal flow rate.

1. General view of the four deteriorated pumps
2. Corroded-eroded pump and cut water
3. Rebuilding the eroded areas inside the pump
4. Completed application

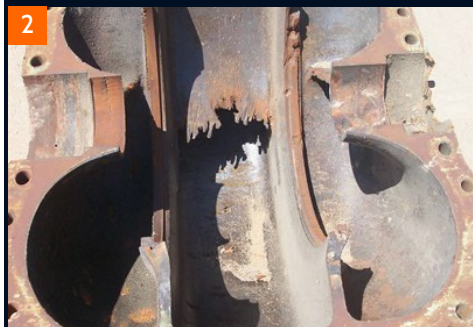
Each of the four pumps was facing many problems in the cutwater and the wear ring seats which decreased the efficiency of the plant. Instead of buying new pumps Belzona was used to repair the old pumps providing extra protection while restoring the plants power without resorting to buying new expensive units.
