# BELZONA REPAIRS BROKEN EDGES OF ENGINE BLOCK

ID: 653

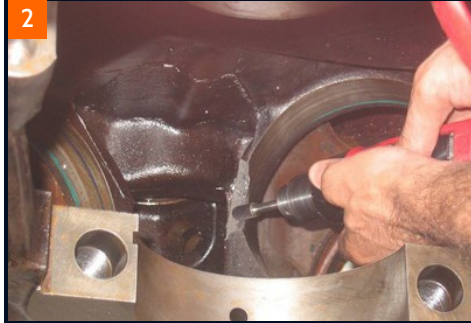
The edge of the engine block was broken.

1. The broken edge of the block
2. Surface preparation
3. Rebuilding the broken edge using Belzona 1111
4. Block was repaired
