# BELZONA REPAIR BY ROPE ACCESS

ID: 654

8-inch diameter Neoprene coated Riser Pipe

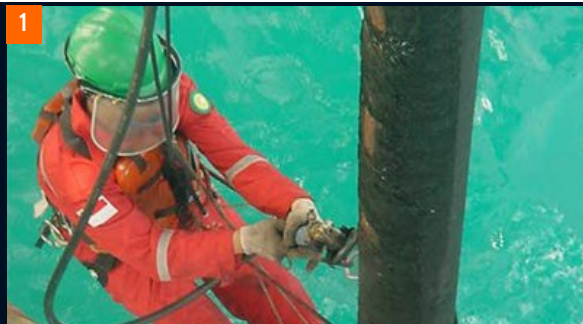
Damage on Neoprene coating and corrosion in splash zone.

1. Preparation of existing Neoprene
2. Rebuild and coating with Belzona 2211 and Belzona 2121
3. Coating splashing zone with Belzona 5831
4. Complete application

Application carried out in accordance with modified Belzona Know-How System Leaflet VPF-3. Existing Neoprene repaired and coated with Belzona® 2211 and Belzona® 2121. Splash zone protected with Belzona® 5831.
