# TYPICAL CHILLER REPAIR WITH BELZONA

Corrosion of tube sheet and the end covers.

Chiller unit from the hotels air conditioning plant.

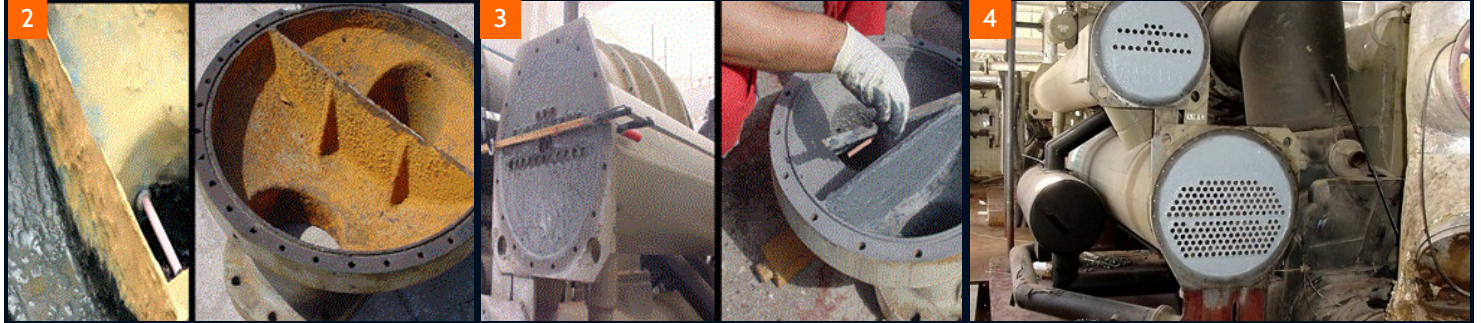
1. The corroded tube sheet.
2. Rebuilding the division bars.
3. End cover being coated.
4. Tube sheets were protected by Belzona 1321.

Application was carried out in accordance with Belzona Know-How System Leaflets HEX-1,-2 & -3.

This is a many times repeated Belzona Application to chiller units. Both corroded tube sheets and end covers were perfectly rebuilt and provide long term corrosion protection.
