# BELZONA RESTORES CORRODED COOLER COVER

ID: 656

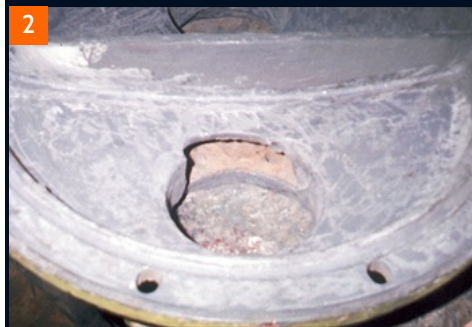
Both the inlet and outlet pipes on the cooler were totally corroded through with large holes in the body of the cover.

1. The cover
2. Rebuilding the division bar completed
3. Rebuilding the inlet and outlet pipes
4. Cover coated to provide overall protection
