# BELZONA 1341 STANDS THE TEST OF TIME AT IRRIGATION PLANT

Impellor from an irrigation pump.

Irrigation Plant, North Queensland, Australia

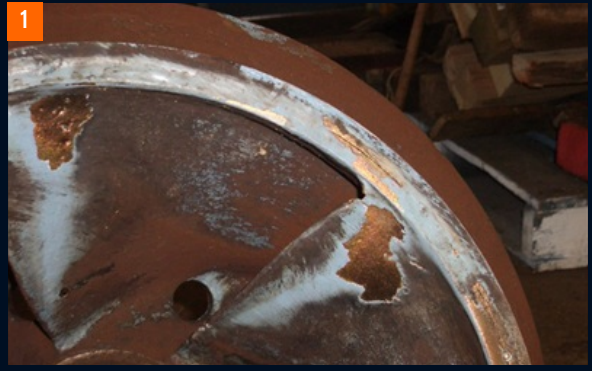
Due to general erosion/corrosion to this impellor, the customer requested sacrificial coating to protect the equipment.

1. Close up of the impellor, showing localised cavitation damage
2. The impellor easily patch repaired with Belzona 1341
3. Deposits from the river water evident on the Belzona coating
4. The deposits removed easily with a paper towel

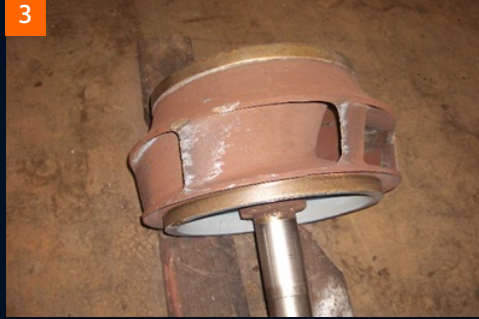
Recent inspection of the impellor revealed, that after 12 years of hard work following the Belzona® 1341 application, wear is minimal. Although there is a brown deposit left on the impellor from the river, it is very easily removed with a paper towel.
