# BELZONA CATION LINING REPAIR

ID: 658

Cation exchange vessel in the water treatment station.

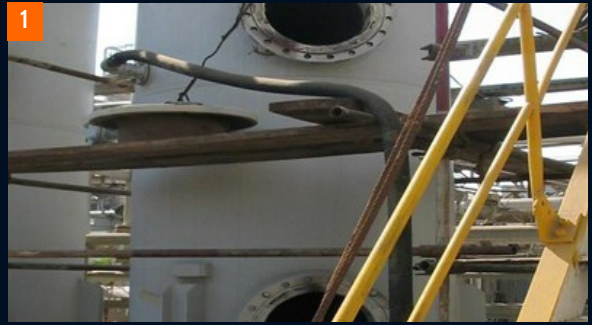
1. General view of the Cation
2. The perished areas inside the cation
3. Surface preparation
4. Belzona 2121 applied

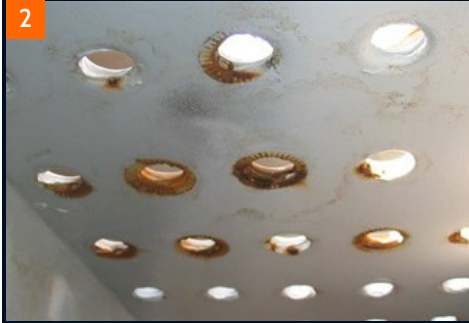
The rubber lining of the cation had deteriorated and had been lost in many places.
