# BELZONA COAL PIPE ELBOWS

ID: 66

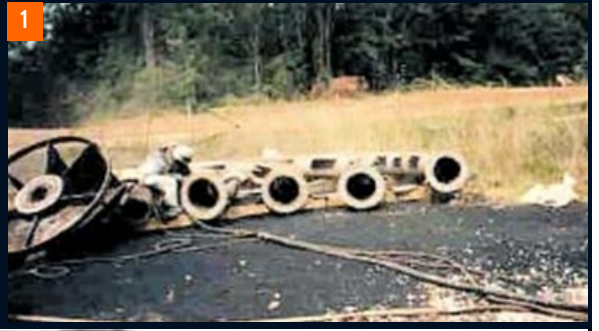
1. Abrasive grit blasting taking place in the yard.
2. Holes cut to gain access, application of product taking place.
3. Belzona 1811 abrasion resistant material in place. Plates will be welded over the holes.

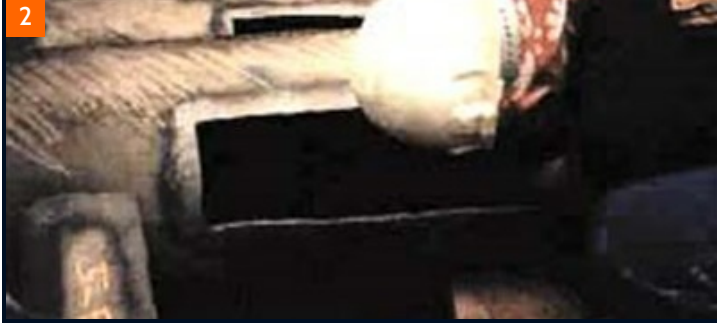
There was no way to get to the damaged area. Consequently, holes were cut in the pipe opposite to the wear area to gain access for the repair. This application is ongoing at the plant and repairs performed have also been in place.
