# BELZONA BUND SEALING TO ENSURE ENVIRONMENTAL COMPLIANCE

ID: 666

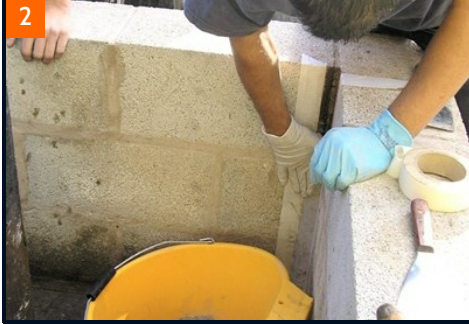
Legislation non-compliance due to newly constructed bund being porous due to construction materials, concrete base and 9 inch concrete block walls.

1. Porous bund floor and side wall
2. Introduction of wall to wall fillets
3. Wall penetrations sealed and fillet complete
4. Finished job

Application carried out in accordance with Belzona Know-How System Leaflet TCC-15.
