# BELZONA REPAIR WORN CATERPILLAR FRONT LOADER ARMS

ID: 667

Caterpillar front loader bucket arms

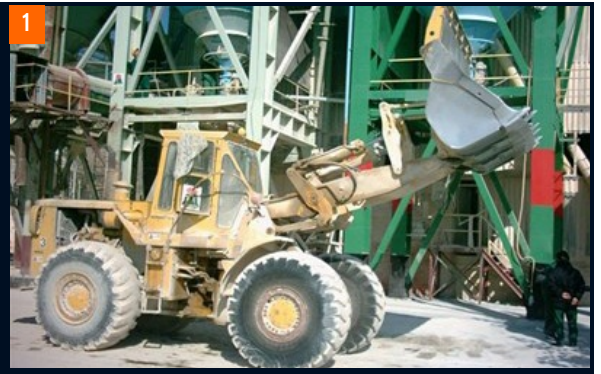
1. Caterpillar front loader
2. Close up of the damage
3. Repair in progress
4. Finished repair

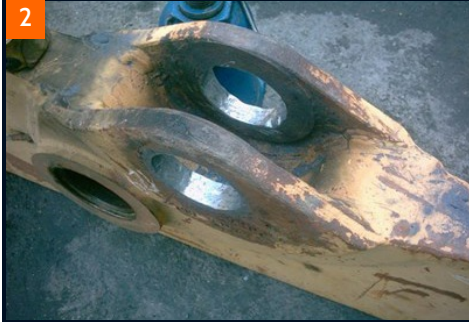
The pivot points for the buckets hydraulic rams had become very worn and were no longer serviceable.
