# BELZONA REPAIRS LARGE HYDRAULIC RAM

ID: 668

Large Hydraulic Ram

Hot Roll Mill for Steel Sheets, Macedonia

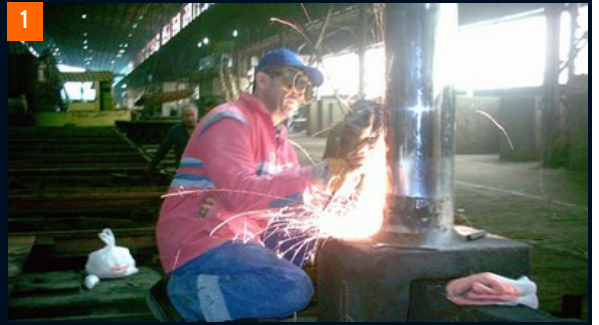
Many years in service had caused large vertical gouges to be worn into the ram

1. Surface preparation
2. Ready for application of Belzona
3. Finished repair

Application was carried out in accordance with Belzona Know-How System Leaflet MPT-3.
