# BELZONA SAVES ANIMAL FEED MANUFACTURER

ID: 669

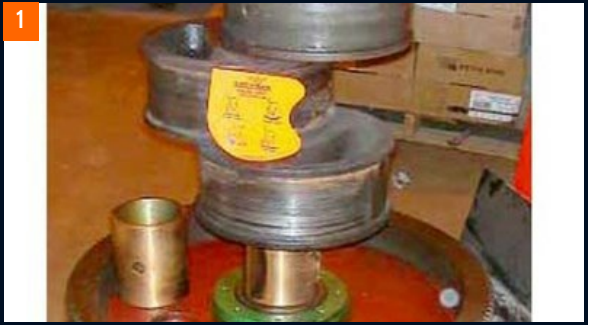
Crankshaft was scored due to debris and low oil levels in the sump.

1. Crankshaft
2. Close up of scored & repaired bottom journal
3. Another close up of the repair

Application carried out in accordance with Belzona System Leaflet MPT-9. Belzona® 1131 was hand applied to the scored journal and subsequently hand finished with fine emery.
