# BELZONA STOPS WINDOW LEAKS

ID: 670

Community College, St. Charles, Missouri  
USA

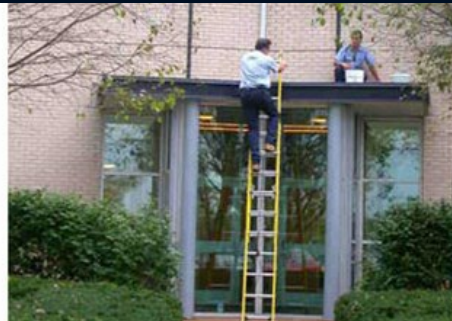
1

1. View of windows above entry canopy.
2. Close up of the problem and start of the repair.
3. Finished repair.

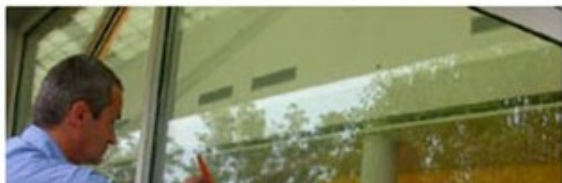
2

The bottoms of the windows had almost imperceptible openings allowing wind blown water to enter and travel to the entry canopy staining the ceiling tile.

Application was carried out in accordance with Belzona Know-How System Leaflet RPA-3.

Belzona 3111 (Flexible Membrane)
