# WASTE WATER PLANT DIGESTER SEALED WITH BELZONA

ID: 671

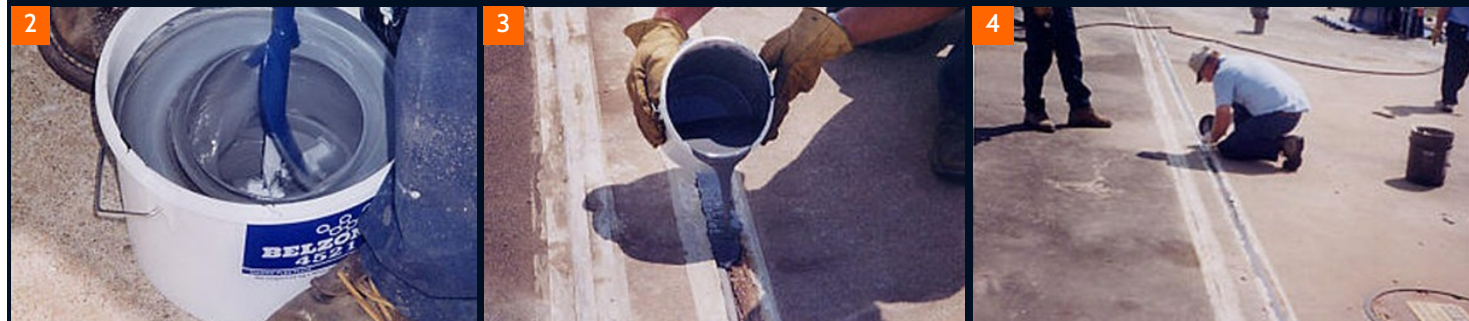
## PHOTOS

Loss of oxygen rich gas caused customer to re-enrich with oxygen monthly. Design conditions called for re-enrichment only three times per year.

Leaking expansion joints at digester top

1. Overview of the digester top.
2. Mixing Belzona 4521.
3. Casting the joint.
4. Close up of joint.

Application was carried out in accordance with Belzona Know-How System Leaflet TCC-12.

Belzona 4521 (Magma-Flex Fluid)  
Belzona 4911 (Magma TX Conditioner)
