# BELZONA CEMENT HOPPER FLANGE REPAIR

ID: 673

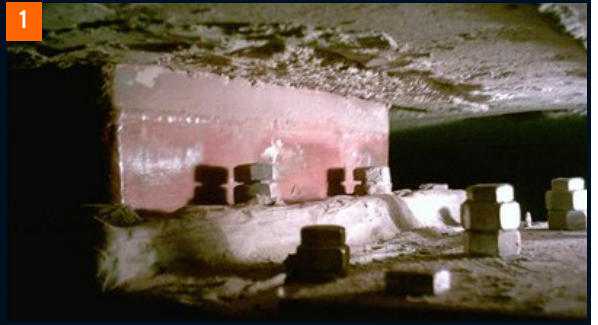
Failure of the rubber gasket allowed cement to fall from the hopper when it was being emptied.

1. Application situation
2. During application of Belzona
3. Finished application
