# BELZONA SEALS ASH VALVE

ID: 674

Cement plant ash valves

Cement Works, Usje, Macedonia

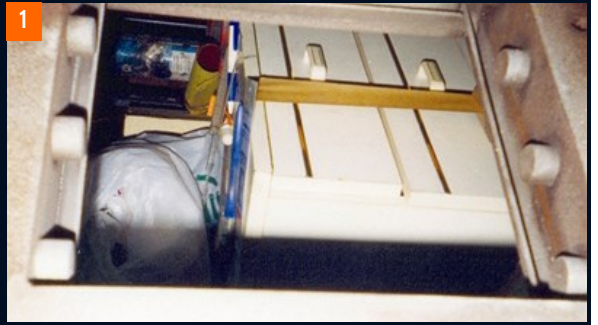
Poor sealing between the steel gate and the valve housing meant that there was a 2-3 mm gap all around the seal area.

1. Ash valve
2. Ash valve during repair

Application was carried out in accordance with Belzona® Know-How System Leaflet GSS-5.

Belzona 2111 (D&A Hi-Build Elastomer)
