# BELZONA PROTECTS CEMENT PACKING MACHINE STEEL PLATES

ID: 675

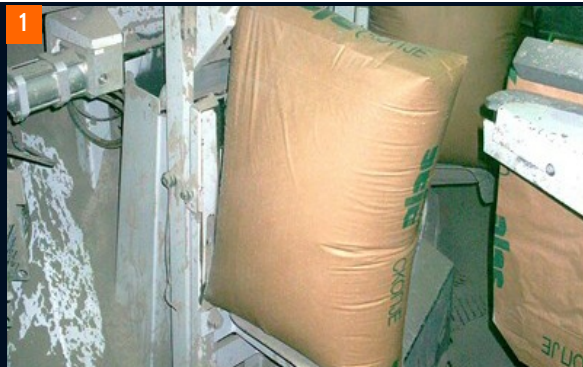
Steel plates and steel seats of a cement packing machine.

1. Cement packing machine.
2. Condition of the coated steel plate and steel seat after one year in service. (Experiment which shows no wear after one year).
3. Repaired seats and sheets.

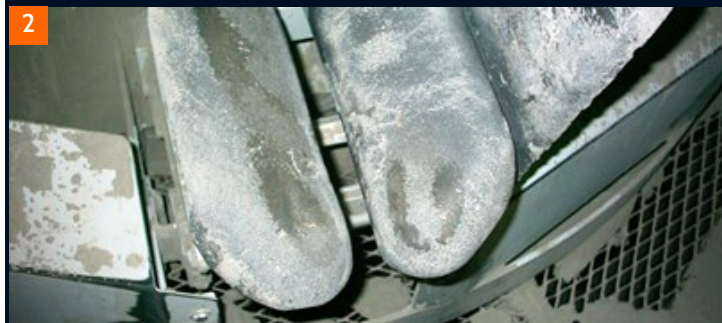
Initially done as an experiment, the cheapest base metal was chosen and coated with Belzona. One year later the plates were inspected and were found have suffered from no wear at all. Belzona® 1812 would be expected to give similar results.
