# BELZONA REBUILDS AND PROTECTS ONBOARD SEAWATER STRAINER

ID: 676

Sea water strainer

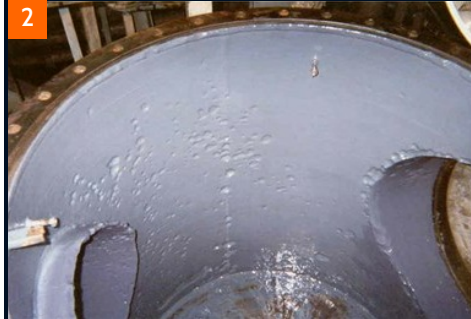
This vessel was less than three years old. Because of impurities in the metal used, the vessel had suffered major metal loss through bi-metallic corrosion. Up to a 1/4 inch of thickness had been lost in various places

1. View of vessel with surface preparation in progress
2. Application of first coat Belzona 1321
3. Application of Belzona 1311 to all eroded areas
4. Application of final coat of Belzona 1321
