# BELZONA REBUILDS A RUDDER PINTLE HOUSING

ID: 677

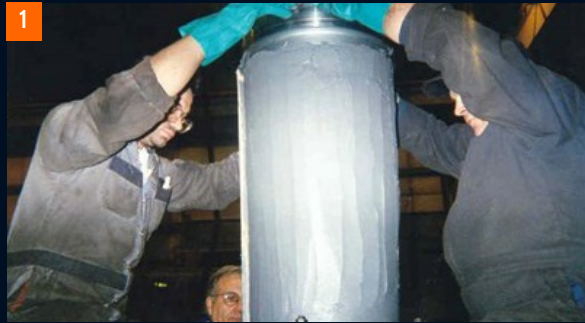
1. View of coated rudder pintle one being inserted into the bore which has also been pre-coated.
2. The pintle now completely inserted and extruded material removed.
3. The pintle removed showing reformed bore giving 100% contact with the pintle.

The rudder pintle housing was oversized and needed to be rebuilt

Application carried out in accordance with Belzona Know-How System Leaflet SOS-3.
