# BELZONA EXTENDS THE LIFE OF ID FANS

ID: 678

ID Fan housing

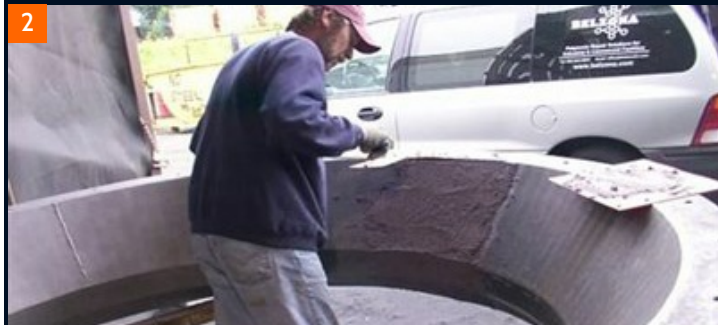
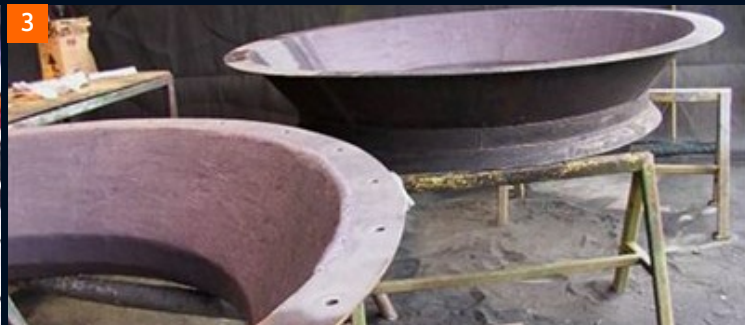
## PHOTOS

The ID fan housing would wear away necessitating replacement every two years at best.

1. Two new housings awaiting grit blasting
2. Application of Belzona 1812 in progress
3. Application to first housing complete with second partially completed

An initial test on an original badly eroded unit proved the cost benefits of the application to the customer. With the Belzona product acting as a sacrificial wear surface minimal metal loss was recorded during the 12-month test period.
