# BELZONA ELECTRICAL CONDUITS MADE SAFE

ID: 68

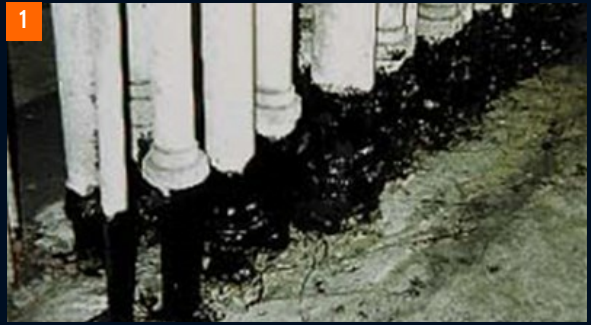
1. Big bank of electrical conduit sealed with Belzona 2111.
2. Another electrical conduit top dressed with Belzona 4131.
3. Close-up view of conduit, also coated with Belzona 3921 for corrosion protection.
