# BELZONA PROTECTS RUBBER PIPES AT WWTP FROM UV ATTACK

ID: 681

Flexible rubber transfer pipes on digester

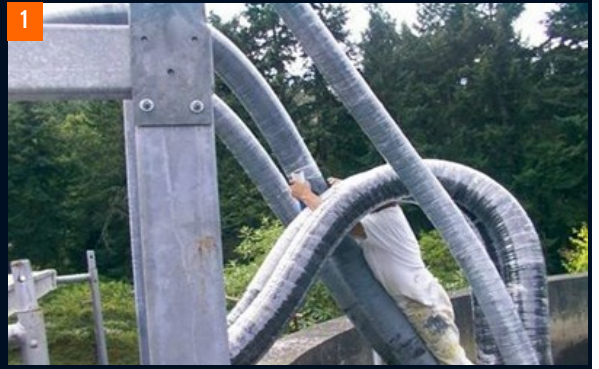
1. Preparation of flexible hoses in progress. All pipes are tightly wrapped with a polythene film to prevent bleed through of the pitch from the rubber component.
2. The flanges are ground and coated with Belzona 3921 GSC Conditioner.
3. Application of Belzona 3211 in progress. Belzona 9311 Reinforcement cloth is incorporated into the 1st coat.
4. Completed application.
