# BELZONA REBUILDS NON-SLIP SAFETY SYSTEM FOR INDOOR POOL AREA

ID: 682

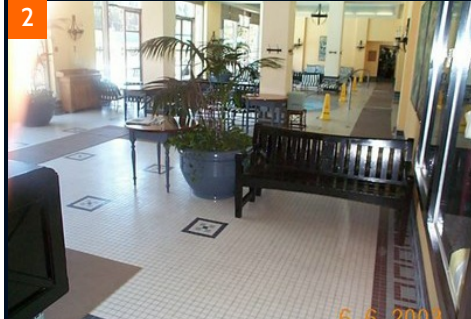
1. View of Whistler Fairmont Resort Hotel
2. A general view of the Health Club showing the floor mats in place
3. When the product had cured, the area was swept with a broom and vacuumed.
4. View of completed application covering approximately 700 sq.ft
