# BELZONA REBUILDS BEARING SURFACE ON PAPER MACHINE DRIVE

ID: 683

Bearing fit on paper machine drive

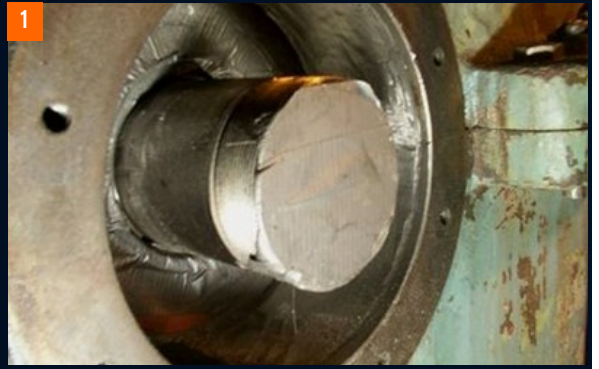
The worn bearing fit on the paper machine drive was causing gear lash problems.

1. The bearing fit area ground to provide a rough surface and degreased with Belzona 9111
2. The mold was positioned carefully before injecting Belzona 1321 (Ceramic S Metal)
3. The mold removed, revealing a perfectly formed new bearing surface
