# BELZONA REBUILDS DAMAGED DRYER CAN JOURNAL IN 5 HOURS

ID: 684

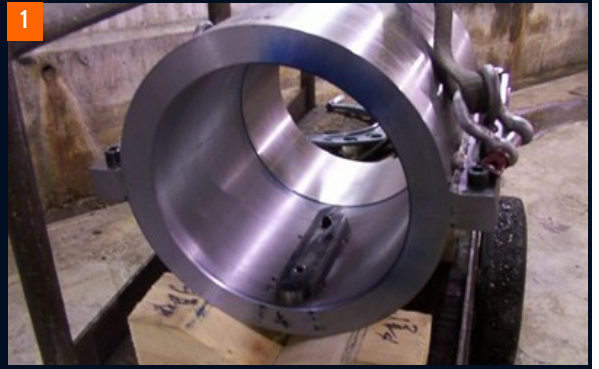
1. View of completed mold with new keyway fitted
2. Grinding of the damaged journal underway
3. The mold has been fitted and the Belzona 1391 HT Ceramic injected - see excess coming out of vent holes on top of mold.
4. Mold removed revealing rebuilt journal

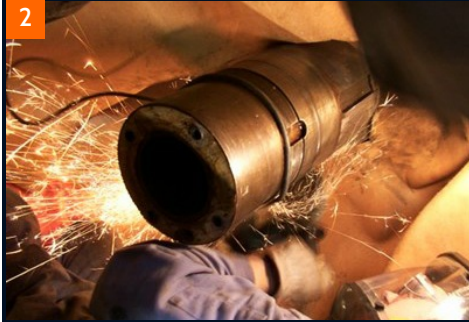
Damaged dryer can journal
