# BELZONA PROTECTS FLANGES OF CONCRETE LINED PIPEWORK

Installation of additional valves into concrete lined cooling water pipework (ranging from 400-1200mm)

Power Station, Germany

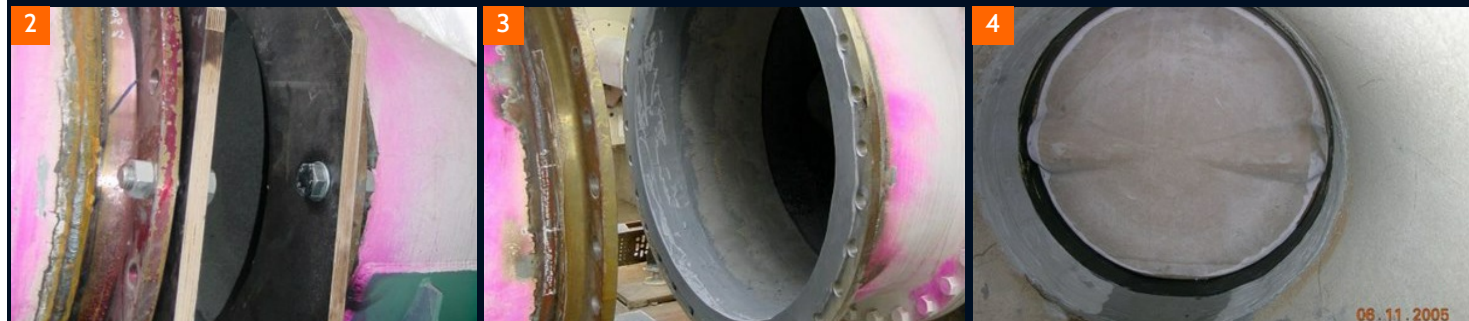
## PHOTOS

The cutting of the pipes damaged the concrete lining and would have resulted in crevice corrosion on the flange face and corrosion creep under the concrete. It was not practical to repair the concrete with more concrete.

1. Blasted steel flange face – note concrete lining also prepared
2. Use of formers as per VPF-13.
3. Completed application
4. Inspection after 3 years service

Fourteen Flanges were protected and all works completed within two days. The cooling water system operates with a maximum pressure of three bar. After inspection following three years service, the satisfied client has specified the use of Belzona 1111 for other damaged concrete lined pipes
