# BELZONA REPAIRS ASH SCREW CONVEYOR BEARINGS

Friction Bearings on Ash Screw Conveyor

Cement Works, Usje, Macedonia

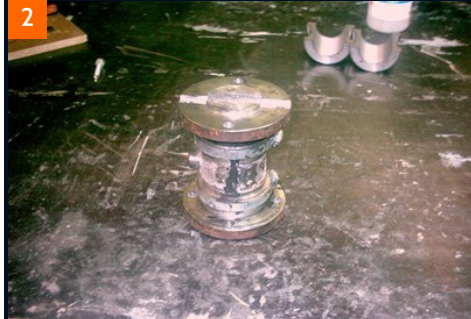
1. Application situation
2. Worn friction bearing
3. Repaired bearings
4. Finished application

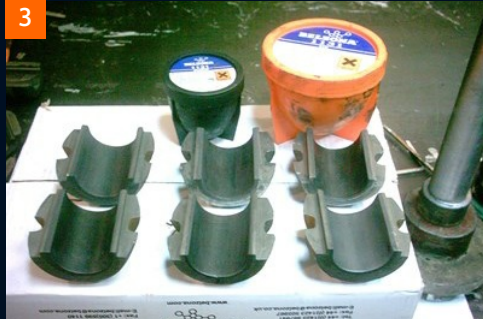
Severe wear due to dusty working environment.

The bearings were made of grey iron and were lasting just 3-4 weeks. Following the application of Belzona® 1131 the bearings were lasting 3-4 months thus saving down time as the bearings needed replacing less often.
