# BELZONA REPAIRS HEAT EXCHANGER END COVERS

ID: 691

Heat Exchanger End Covers

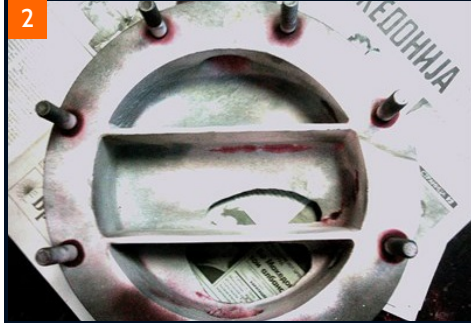
Holes and cracks had appeared on the end covers due to freezing water.

1. Damaged end cover
2. Surface preparation
3. Belzona 1111 rebuild
4. Finished application with Belzona 1321 coating
