# BELZONA REPAIRS CRACKED STEEL TUNNEL

Steel Tunnel

Cement Works, Usje, Macedonia

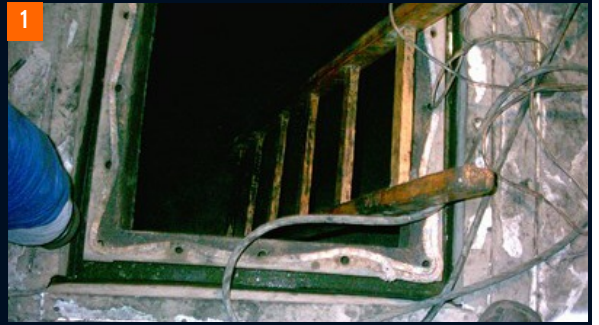
A 700mm long crack had appeared on the weld joint of the steel walls

1. Steel tunnel entrance
2. Crack in steel tunnel
3. Belzona 1221 repair

The customer had tried to apply Silicone under the crack but it had failed within a month. This Belzona solution was designed to be a temporary solution to last 3 months until the plant was shut down when a weld repair could be carried out. The customer was very pleased with the outcome and the costs which were saved through not having to shut the plant down earlier than planned.

Belzona 1221 (Super E-Metal)
