# BELZONA REPAIR OF ACCESS RAMP AND STEPS

ID: 693

Heavily worn steps and disabled access ramp

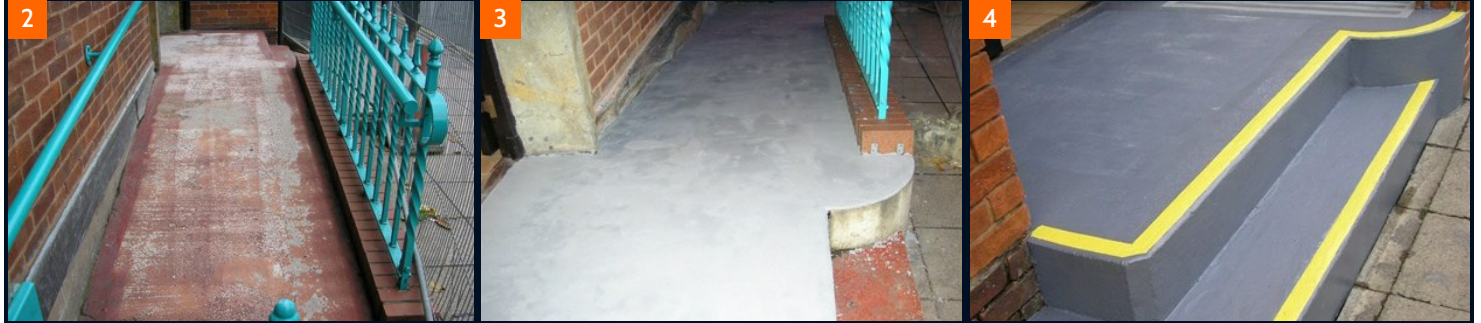
## PHOTOS

Much foot traffic and heavy weathering caused the steps and disabled access ramp of these public toilets to become damaged and worn. An inspection of the ramps according to the Disability Discrimination Act (DDA) found them to be unsafe and not compliant.

1. Worn steps were a health and safety hazard
2. Prepared surface
3. Surface rebuilt with Belzona 4131
4. Completed project

Application was carried out in accordance with Belzona Know-How System Leaflet FPA-1.

The use of Belzona products was requested by the council in order to give a fast, long life, cost effective repair. The ability to bond and build up old concrete meant that the steps did not have to be completely removed and rebuilt. This ensured that the toilets would comply to the DDA standards. These heavily used toilets were quickly reopened to the public.
