# BELZONA REPAIRS CORRODED ROOF OFFSHORE PLATFORM

ID: 694

Heat recovery unit roof on offshore production platform

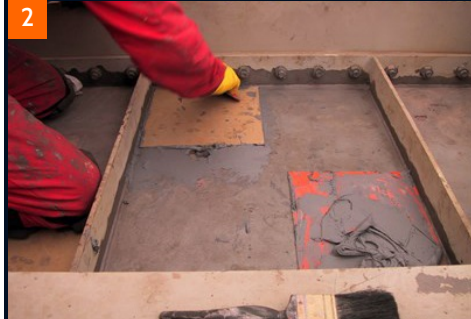
Salt water had collected on the roof and combined with the heat from beneath had caused rapid corrosion. The roof had holed in numerous places.

1. Holed steel roof
2. Application of Belzona 1111
3. Repaired surface
4. Protected surface

Application was carried out in accordance with modified Belzona Know-How System Leaflets RPA-7 & TCC-5. Steel plates were bonded on using Belzona® 1111 and then protected with Belzona® 5811.
