# BELZONA PROVIDES LONG TERM PROTECTION IN HIGH TEMPERATURE SULPHUR

ID: 695

Sulphur pit internal equipment

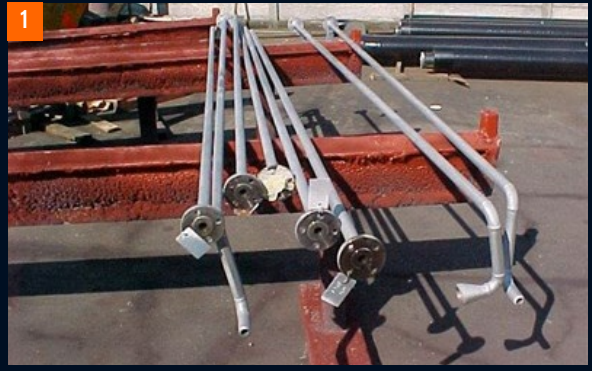
1. Pipes ready for application
2. Brush application of Belzona 1591
3. Coated pipes

Application was carried out in accordance with Belzona Know-How System Leaflets VPF-2.
