# BELZONA WEATHERPROOFS AIRPORT FIRE STATION ROOF

ID: 696

Airport fire station roof

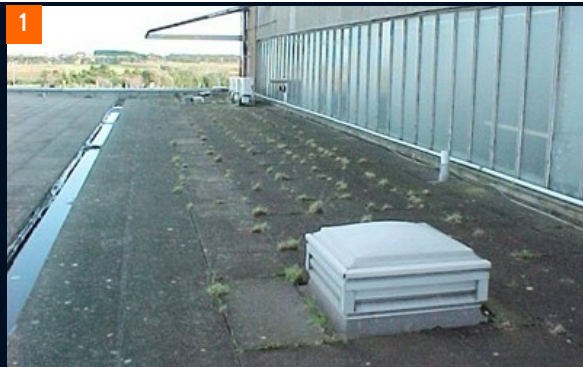
1. Roof to be coated
2. The roof after cleaning and surface preparation
3. Coated roof
4. Completed application
