# BELZONA GRIP SYSTEM HELPS POWER PLANT

Conveyor belt drive roller

Coal Fired Power Plant, Macedonia

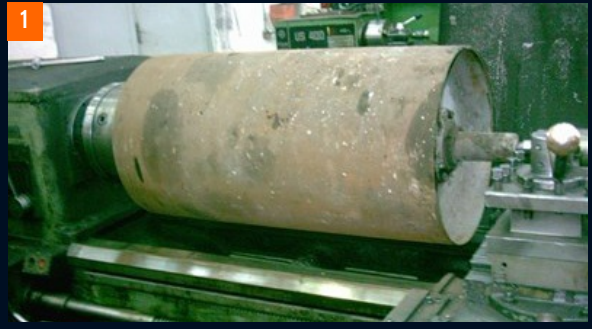
The original rubber lagging had worn away and the loss in friction was allowing the belt to slip and lose efficiency.

1. Roller in poor condition prior to application
2. Surface preparation
3. Completed application
