# BELZONA REPAIRS HOLED VALVE HOUSING

ID: 699

Cavitation had caused the valve housing to become holed

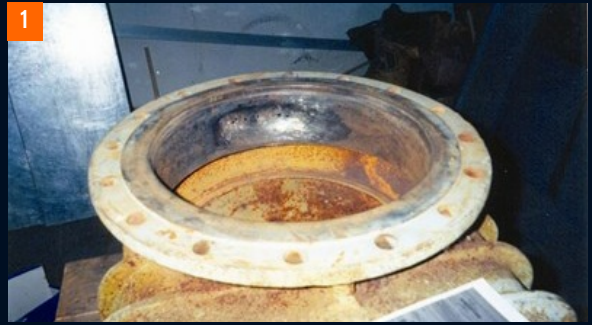
1. Holed valve housing.
2. Metal plates used to reinforce the exterior.
3. Rebuilt housing.
4. Completed application.
