# COOLING TOWER FAN BLADES REPAIRED WITH BELZONA

Fan blades of cooling tower - 14' long.

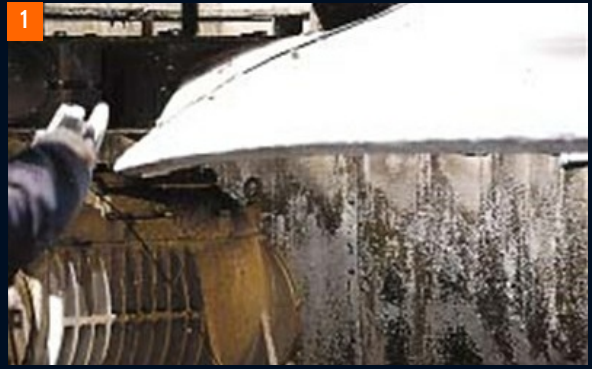
Light damage and erosion on the leading edge of the blades reduces the overall efficiency and operation of the cooling system.

1. Surface preparation by grinding.
2. Taping off for a neat repair.
3. Finished repair. Leading edge protected with Belzona.

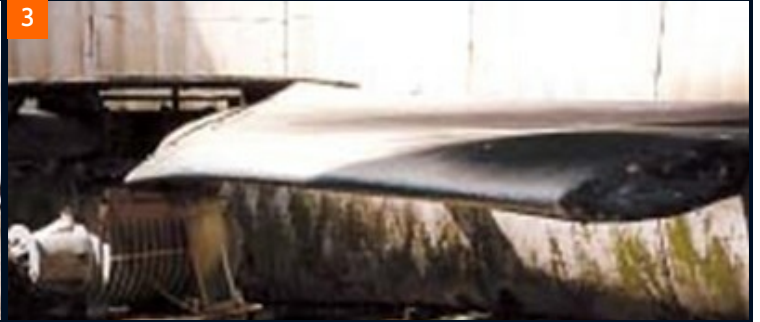
After 14 months, fiberglass blades on new units needed replacement at a cost of \$125,000. Over two years later the Belzona repair is in excellent condition. The plant has saved over \$200,000 in new blade replacement cost.
