# BELZONA SEALS LEAKING TRANSFORMER FLANGES

ID: 700

Electricity Transformer Flanges

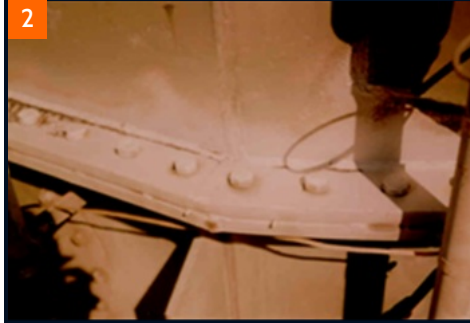
Oil was leaking out between the flanges.

1. View of oil covered flange
2. Flanges degreased and blasted to provide a good rough surface profile
3. Application in progress with bolts being sealed first
4. Completed application
