# BELZONA SEALS INSULATOR LEAKS

ID: 702

Power Line Insulators

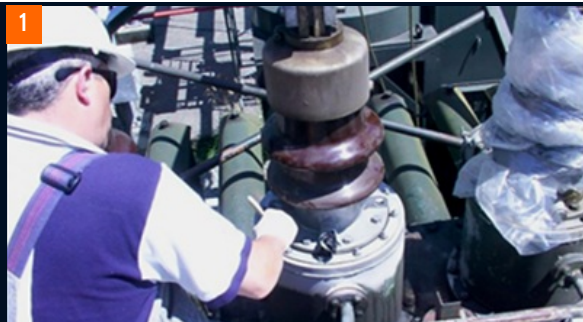
Seal within insulators eroded and as a result oil leakage began to occur.

Surface preparation in progress  
Surface preparation by grit blasting completed  
Completed application.

Application carried out in accordance with Belzona Know-How Leaflet GSS-3.
