# BELZONA REPAIRS LEAKING TRANSFORMER

ID: 704

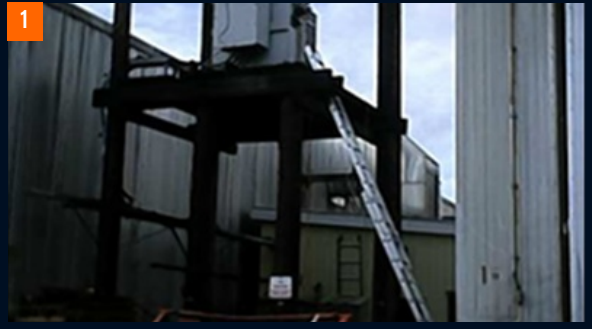
The cooling fins of the transformer had been damaged. Previous repairs lasted only a short while.

1. View of leaking transformer.
2. Surface preparation completed.
3. After initially sealing the hole with Belzona 1221 Super E Metal area received a final overcoating layer of Belzona 1111 Super Metal.
