# BELZONA SEALS SF6 LEAKS AT HYDROELECTRIC POWER STATION

ID: 705

Hydroelectric Power Plant, British Columbia, Canada

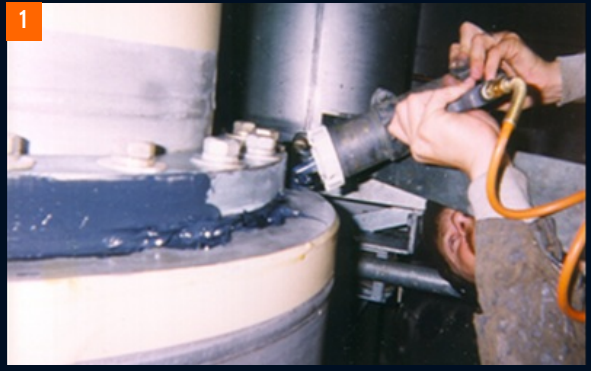
SF6 gas was leaking from the joints of the system requiring regular refilling.

1. Belzona 2211 was injected into the gap between the 2 flanges.
2. Application shown in #1 completed.
3. Another flange sealed.

Application carried out in accordance with Belzona Know-How System Leaflet GSS-4.
