# BELZONA REPAIRS AND IMPROVES FRANCIS TURBINE RUNNER

ID: 707

Hydroelectric Power Plant, Czech Republic

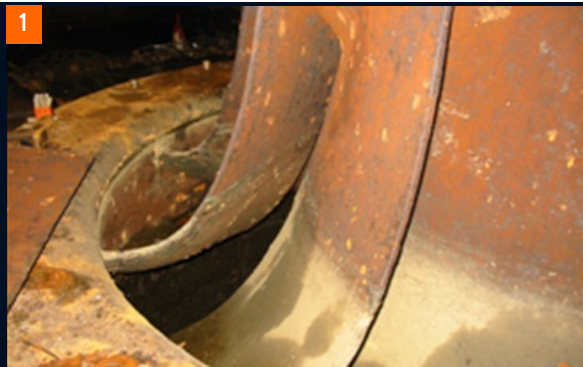
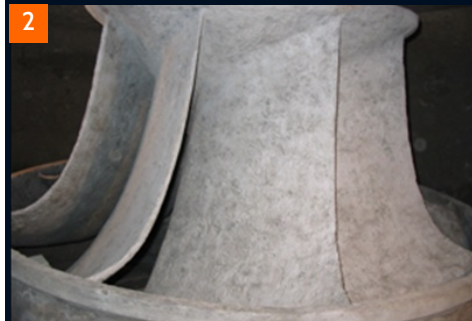
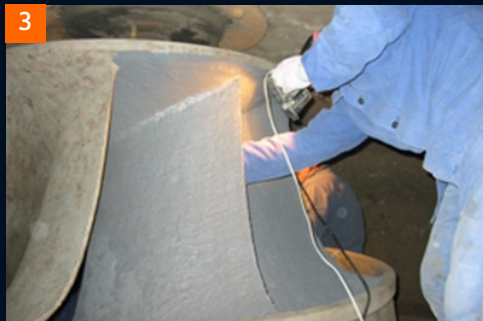
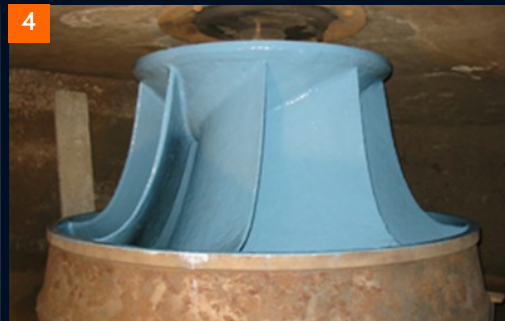
## PHOTOS

The runner had suffered extensive damage from erosion, corrosion and mechanical damage.

Damaged and worn runner After grit blasting Rebuilding with Belzona 1111 After coating with Belzona 1341

The application was carried out in accordance with Belzona® Know-How System Leaflets CEP-8 and CEP-10.

After the repair and coating of both the runner and wicket gates a 10 - 15% increase in output was recorded and the turbines were able to run at a greater range of heads than were possible before, thus earning the customer many time more in profit than the cost of the repair. After one year operation the runner was inspected and was found to have only suffered minor damage due to impact with pieces of wood. A further inspection in 2006 showed runner still to be in excellent condition and in 2010 client expressed himself happy with the application.
