# BELZONA REPAIRS FRANCIS TURBINE WICKET GATES

Francis Turbine Wicket Gate

Hydroelectric Power Plant, Czech Republic

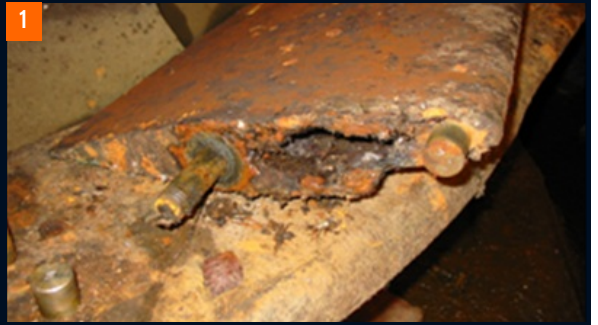
Impact by debris in the water in conjunction with erosion and corrosion had left this turbine in a terrible state of repair and in need of replacement

Damaged Wicket Gate Blade  
Blade After Grit Blasting  
Blade After Rebuilding With Belzona 1111  
Blade After Coating With Belzona 1341
