# BELZONA GIVES A FRANCIS TURBINE A NEW LEASE OF LIFE

Francis turbine runner

Hydroelectric Power Plant, Czech Republic

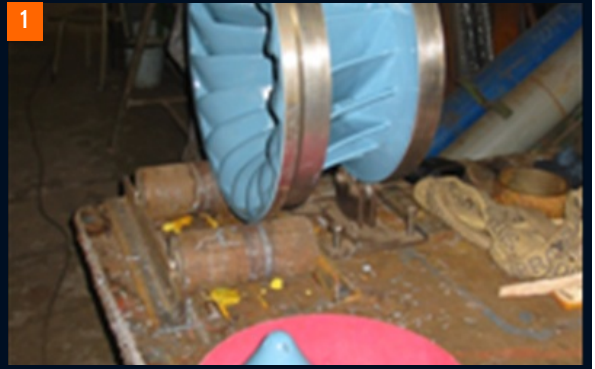
The working surfaces on the runner had suffered from erosion causing the turbine to lose efficiency.

1. The Turbine runner
2. After application
3. Coated with Belzona 1341

Application was carried out in accordance with Belzona Know-How System Leaflets CEP-8 and CEP-10.

Belzona was chosen to protect the turbine from the erosion and corrosion for its ability to increase the efficiency of the turbine.

Belzona 1111 (Super Metal)  
Belzona 1341 (Supermetalgilde)
