# BELZONA TWO MAIN TURBINE COOLING WATER HEADS

ID: 71

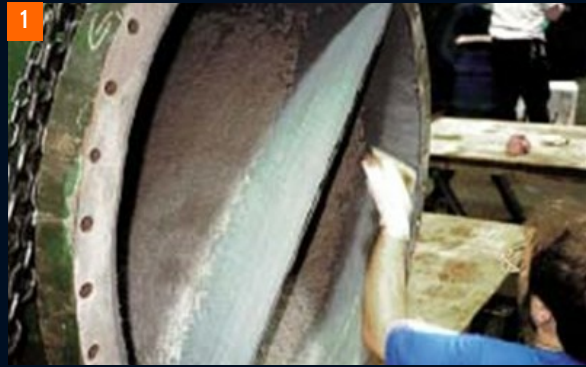
As the headers feed water through main turbine cooling system, erosion/corrosion damage to divider plates and interior surface occurs.

1. Surface preparation complete, rebuilding eroded areas with Belzona 1111.
2. Application of second coat of erosion/corrosion resistant Belzona 1341 begins.
3. Completed application showing headers repaired and protected.

The application was carried out in accordance with Belzona Know-How Leaflets HEX-2 and HEX-3.
