# BELZONA PROTECTS HYDROELECTRIC TURBINES

Two Kaplan Turbines

Hydroelectric Power Plant, Czech Republic

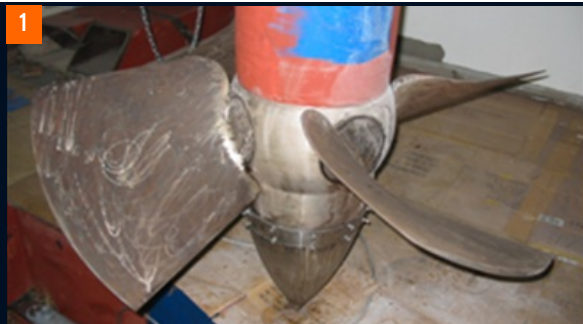
Erosion caused by entrained particles in the water, there was also corrosion damage present.

1. Damaged Turbine 2. Application Situation 3. Coated Blades 4. Completed Application
