# REBUILD AND PROTECTION OF A FRANCIS TURBINE WITH BELZONA

Hydroelectric Power Plant, Czech Republic

June 2005

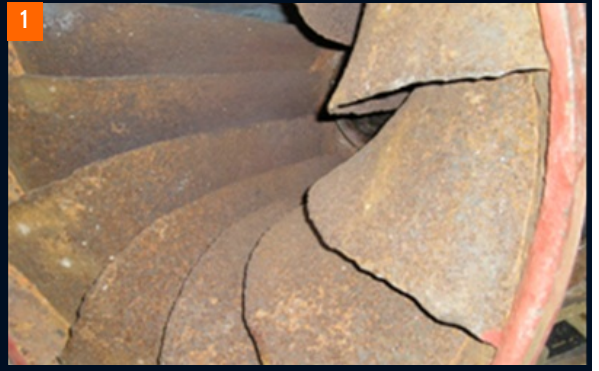
The turbine was not running efficiently due to extensive erosion and corrosion damage.

1. Application Situation
2. After Grit Blasting
3. After Rebuilding With Belzona 1111
4. After Coating With Belzona 1341

The client had tried to repair the blades with weld repairs but these had caused the blades to distort and warp. The Belzona was an attractive solution because it was quick and simple to rebuild the damaged blades and to protect and enhance the efficiency of the turbine with Belzona materials.
