# BELZONA REPAIRS A HYDROELECTRIC TURBINE

ID: 713

Francis Turbine

Hydroelectric Power Plant, France

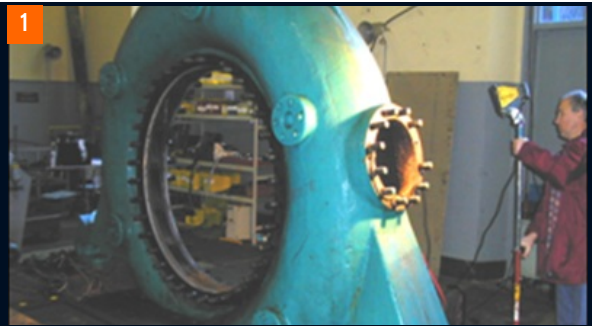
1. The Francis turbine 2. The extent of the damage 3. The completed application 4. Turbine after 11 years in service

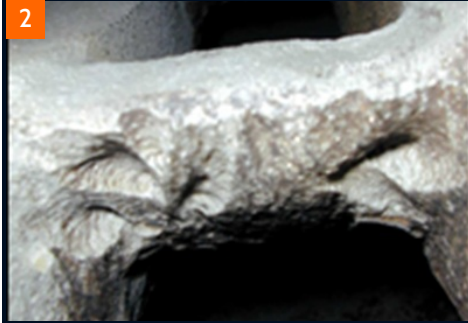
Erosion, corrosion and cavitation of the stay vanes and the casing had induced vibration into the turbine and was also making the turbine run inefficiently.

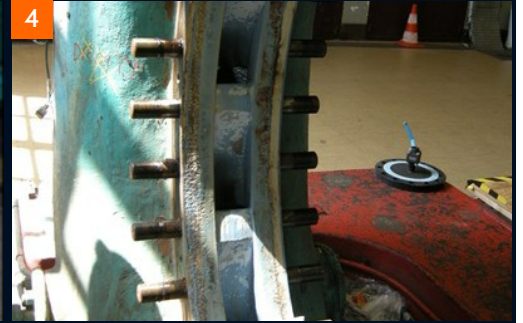
Once back in service the turbine once again achieved its maximum efficiency. The coatings were also chosen to protect the turbine from further damage. An inspection of the turbine following 11 years of service showed that the repair was in excellent condition with only minor damage to the coating, due to erosion from entrained solids, being observed.
