# BELZONA UPGRADES WEAR PLATES ON PELTON TURBINE

ID: 714

Pelton Turbine

Hydroelectric Power Plant, France

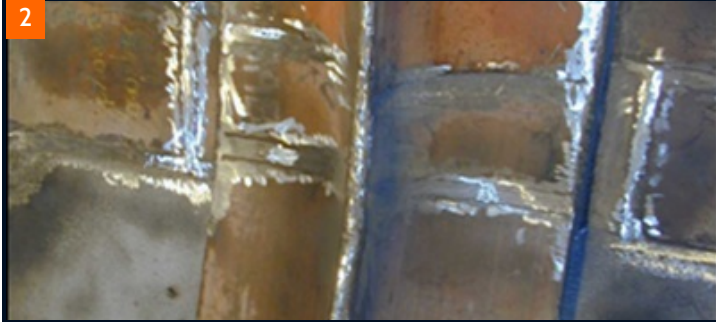
Vibration had lead to weld failure on the splash plates and the anti-wear plates needed replacing

1. Application Situation
2. Weld Failure
3. Belzona 1812 in Situation

Belzona® 1311 used to seal around wear plates and Belzona® 5811 was injected into the cavity behind the wear plates. Belzona® 1812 then applied over the top as a sacrificial coating.
